Australian Standard 5113
Fire Propagation Testing and
classification of external walls of
buildings

QT Panel with 10mm TCS
Cement Render

PRODUCT EVALUATION
AND TESTING

IGNL-3282-08 I02 R00

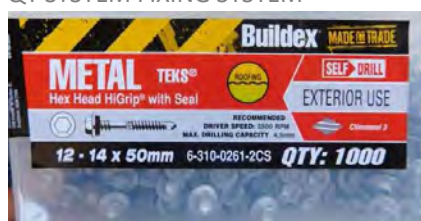
FIGURE 1:

QT SYSTEM FIXING SYSTEM

- 2 x 13mm Fire rated plasterboard | CSR Fyrecheck (fixed to test wall sub-frame)
- Steel Top hats 20x25x50x25x20 1.15BMT fixed to stud frame through the fire grade plasterboard at 450mm spacings.
- 50mm QT panel horizontally installed with QT Buttons and fixed with 12-14 x 50mm Metal hex screws.
- The vertical joint as well as the horizontal joint located at 2.4m above the combustion chamber were installed as control joints with a 10mm gap. Polyurethane backing rod was installed and the gap sealed with Bostic FireBan One to a depth of 10mm.
- 10mm TCS concrete render was installed over the completed QT Conpolcrete wall system

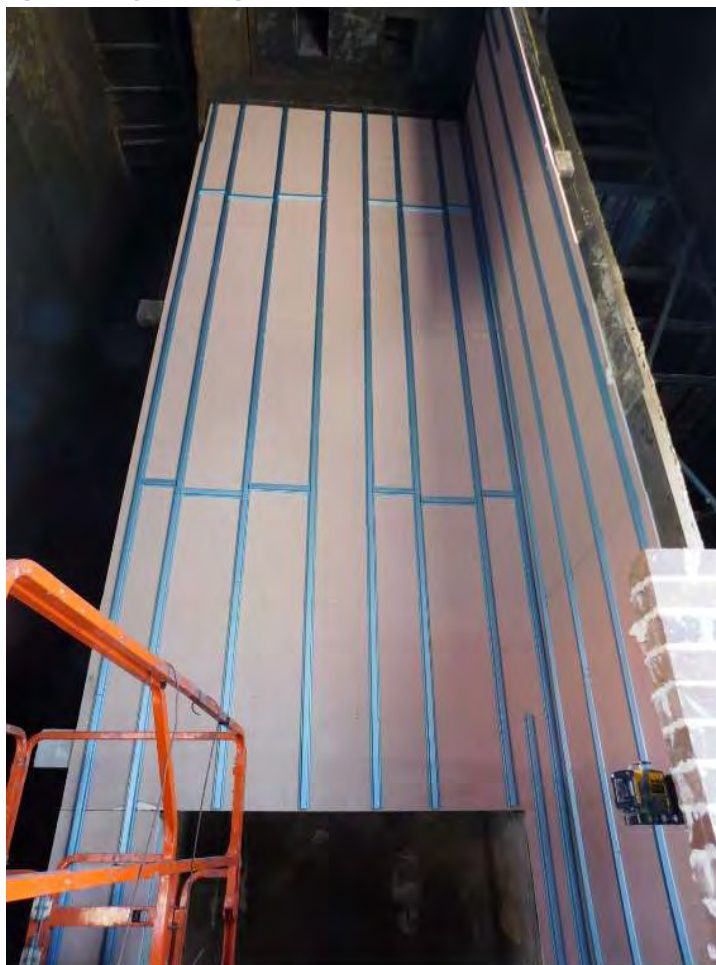
FIGURE 2:

TOP HAT INSTALLATION

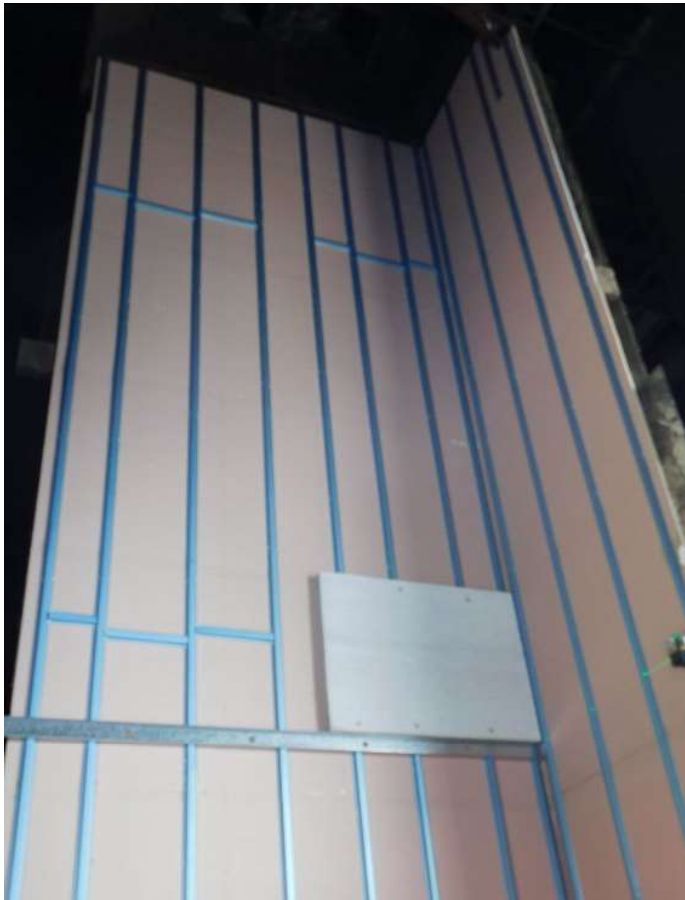
FIGURE 3:

QT SYSTEM INSTALLATION

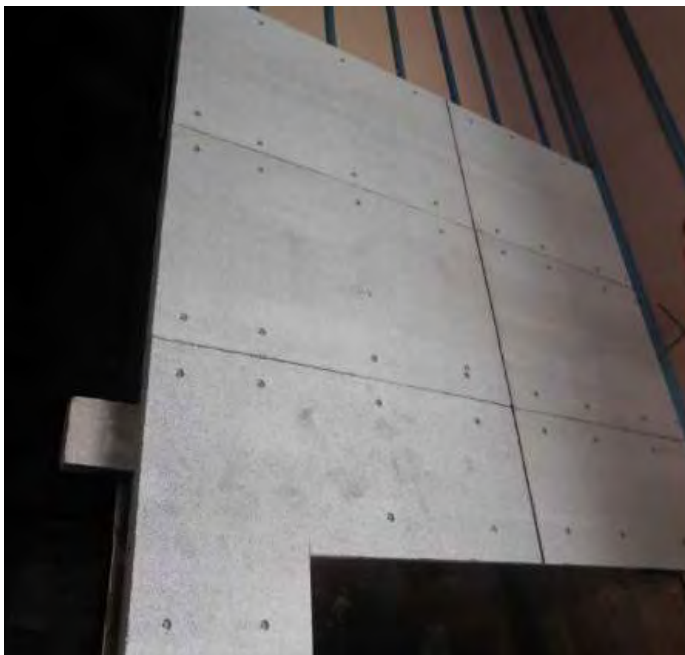
FIGURE 4:

QT SYSTEM INSTALLATION

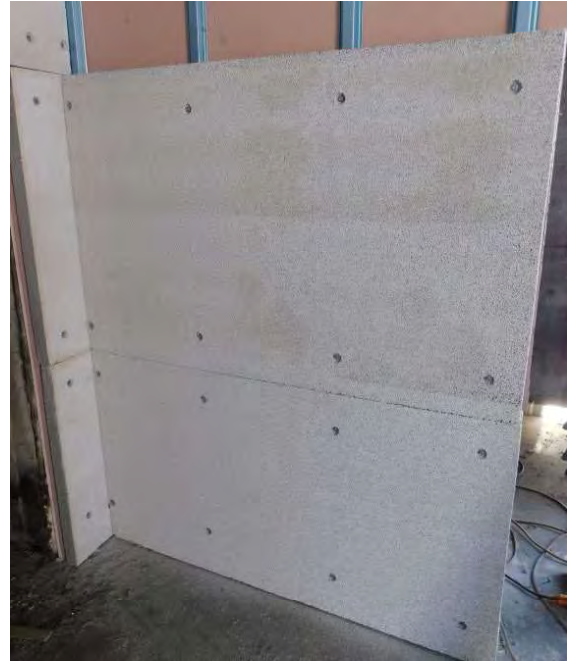
FIGURE 5:
QT SYSTEM INSTALLATION

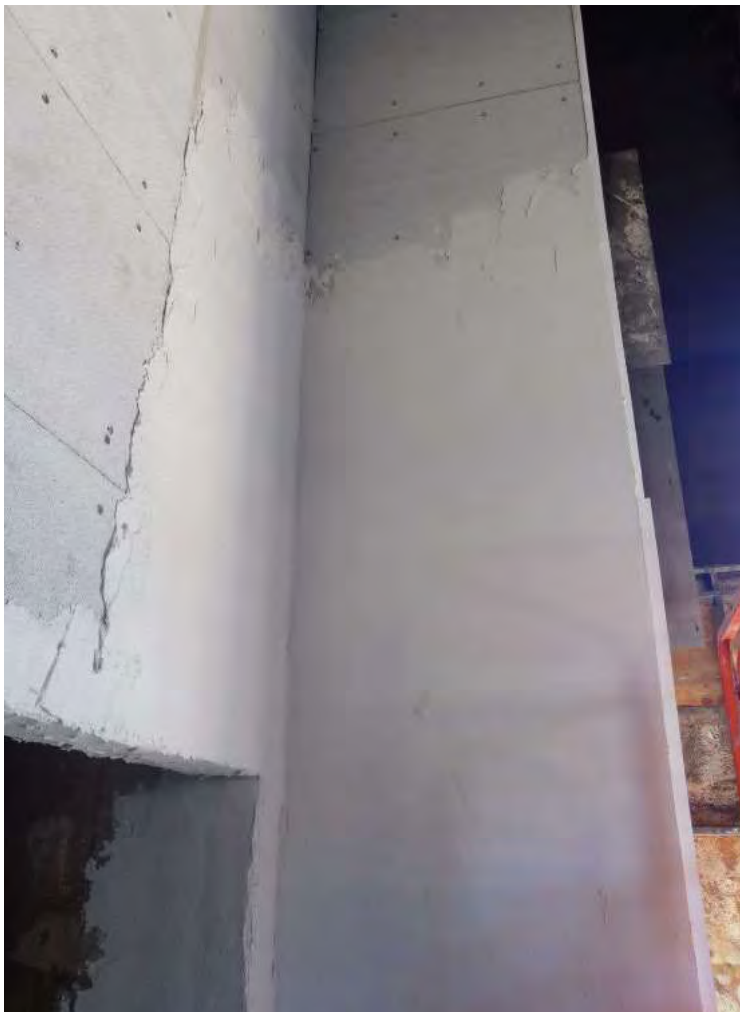
FIGURE 6:
CEMENT RENDER INSTALLATION

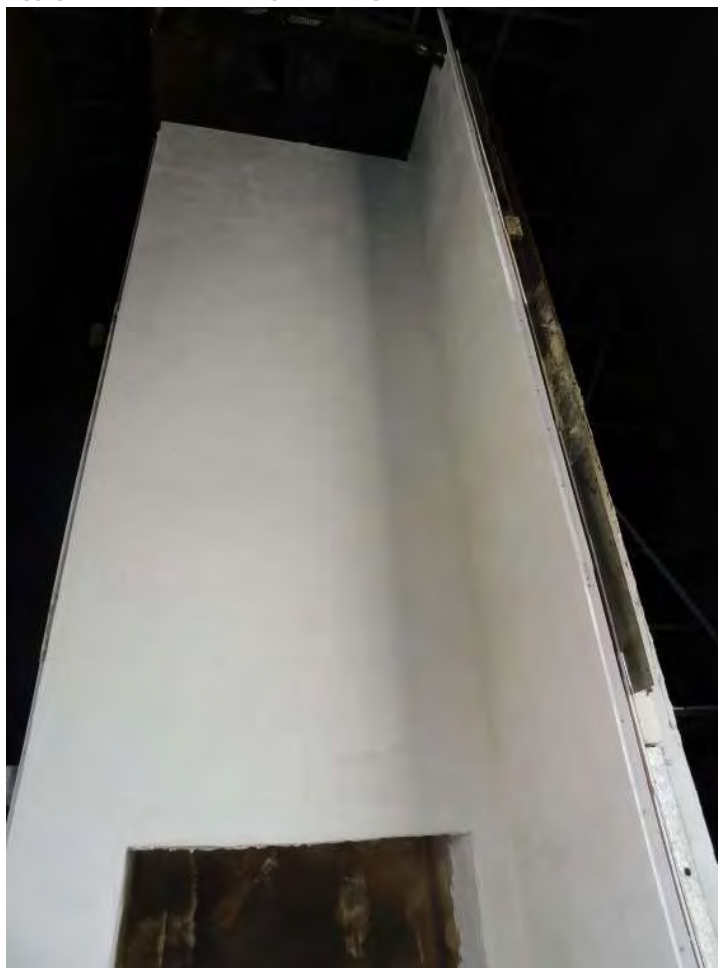
FIGURE 7:

TCS CEMENT RENDER INSTALLATION

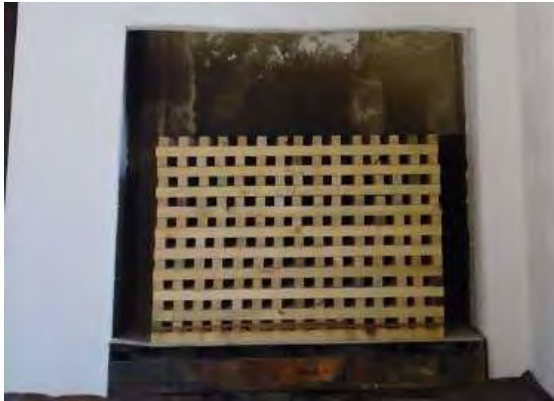
FIGURE 8:

The timber crib included 1500-mm wide, 1000-mm deep and 1000-mm high of pinus radiata being in the order of 50 mm square section. The crib was located centrally within 250mm of each side and within 100mm to the front and rear of the crib platform. Each crib timber element was measured with a J-2000 Delmhorst moisture meter where the moisture content was 10.1%. The following image details the timber crib installation.

TIMBER CRIB INSTALALTION

The crib platform was located on a plinth comprising a single layer of 16mm CSR Fyrecheck and a steel sub-frame to a height of 410mm for the test.

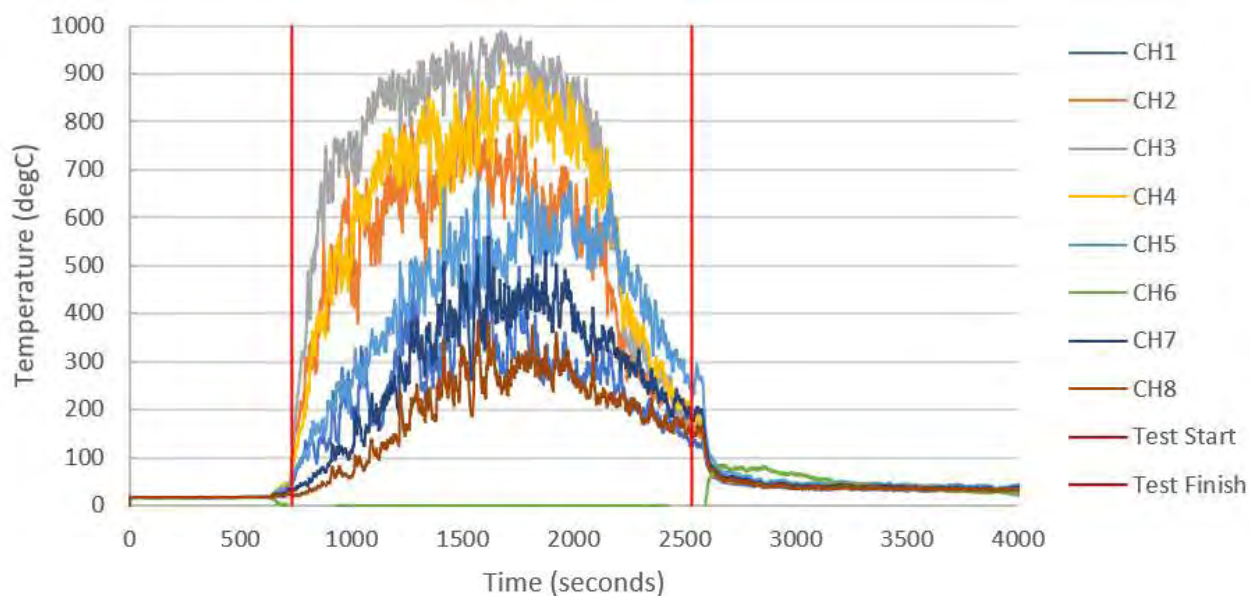
FIGURE 10:

EXTERNAL LEVEL 1 THERMOCOUPLE MEASUREMENTS

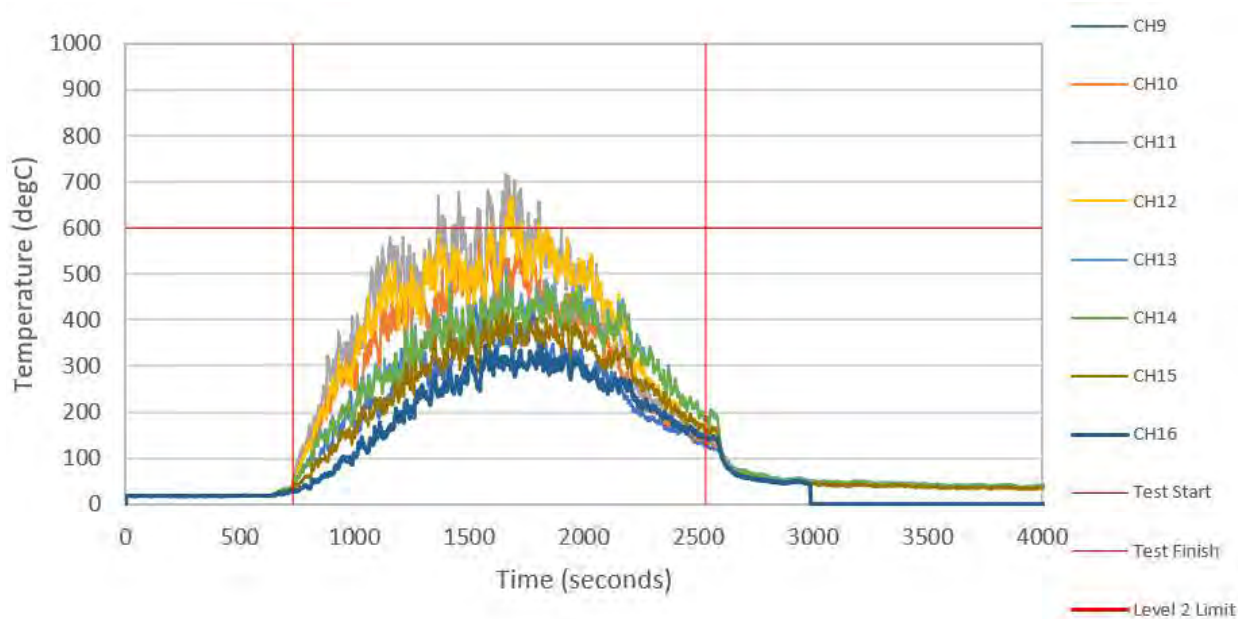
FIGURE 11:

EXTERNAL LEVEL 2 THERMOCOUPLE MEASUREMENTS

Spikes in the temperature for thermocouple 11 and 12 increased over 600°C for an average of approximately 10 second intervals with a maximum time of 30 seconds in one instance. In accordance with Clause 5.4.5(a) of AS 5113-2016 Amendment 1 2018 the temperature shall not exceed 600°C for a continuous period greater than 30 seconds. Within the test the temperature did not exceed 600°C for greater than a 30 second continuous period.

Classification Criteria	Related Classification Measure	Pass/Fail
5.4.5(a) T_{w5m}	$\leq 600^{\circ}\text{C}$	Max 717°C spike @ 15 min <10s PASS
5.4.5(b) $T_{\text{Insulation}5m}$	$\leq 250^{\circ}\text{C}$	Max 55°C PASS
5.4.5(b) $T_{\text{Cavity}5m}$	$\leq 250^{\circ}\text{C}$	Max 101°C PASS
5.4.5(c) $T_{\text{unexposedside}0.9m}$	$\leq 180^{\circ}\text{C}$	Max 27°C PASS
5.4.5(d)flaming	No flaming	No flaming PASS
5.4.5(d)openings	No openings	No openings PASS
5.4.5(e)spread	No spread beyond specimen	No spread occurred PASS
5.4.5(f)debris flaming	$\leq 20\text{s}$	No Flaming debris PASS
5.4.5(g)debris mass	$\leq 2\text{kg}$	No debris PASS
Classification		EW

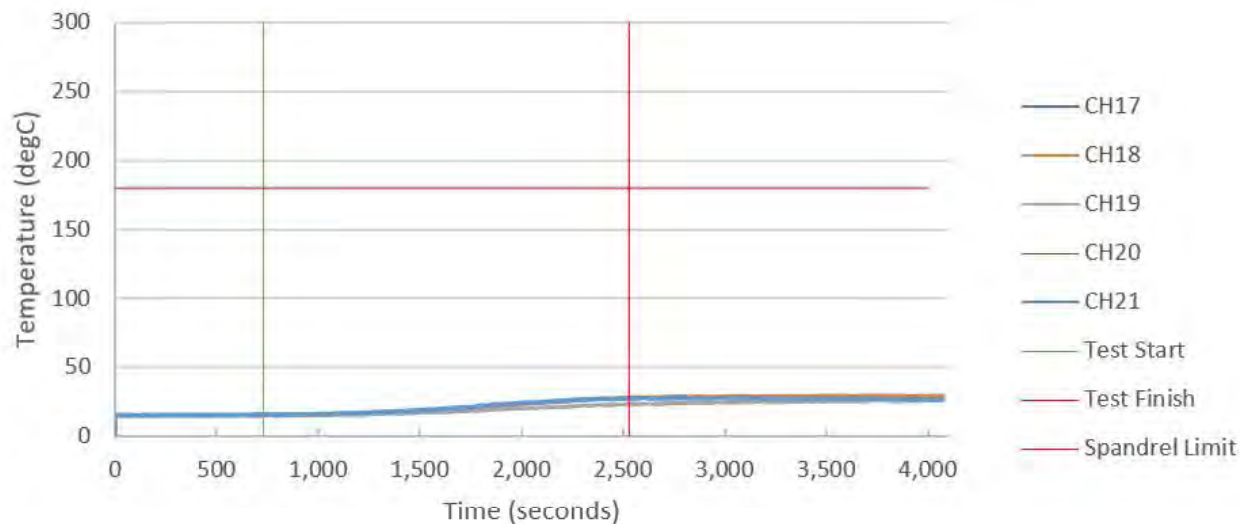
FIGURE 14:

SPANDREL THERMOCOUPLE MEASUREMENTS

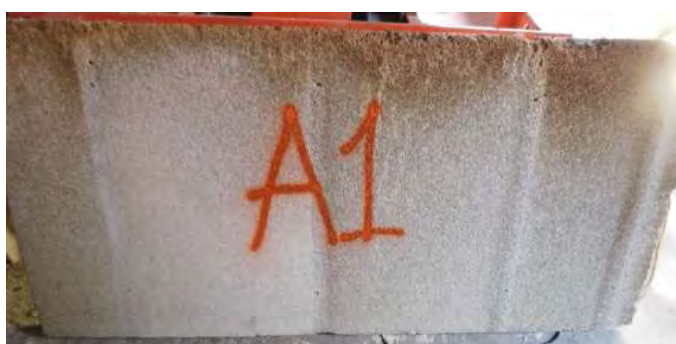
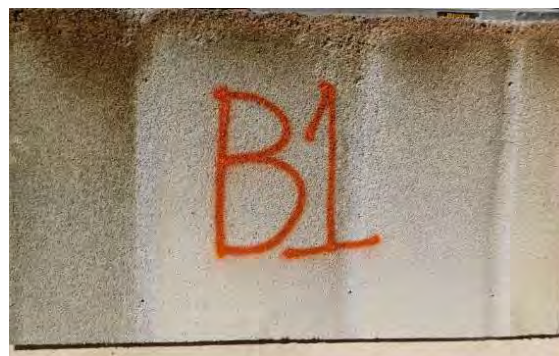
FIGURE 15:

At the conclusion of the test, the top panels of the main wall were removed and the rear of the panels observed. Whilst heat damage was noticed on the edge of the panel, there was no evidence that continuous burning on the back of the panel occurred. The following figure shows the back of the two panels located at the top of the main wall.

BACK OF QT PANEL AT TOP OF SPECIMEN

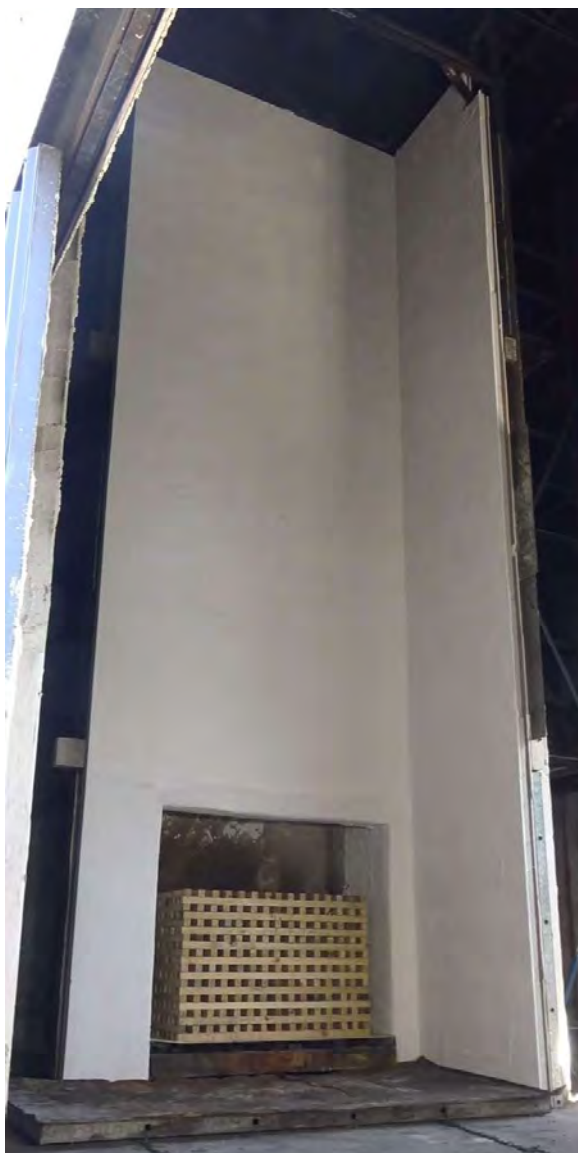
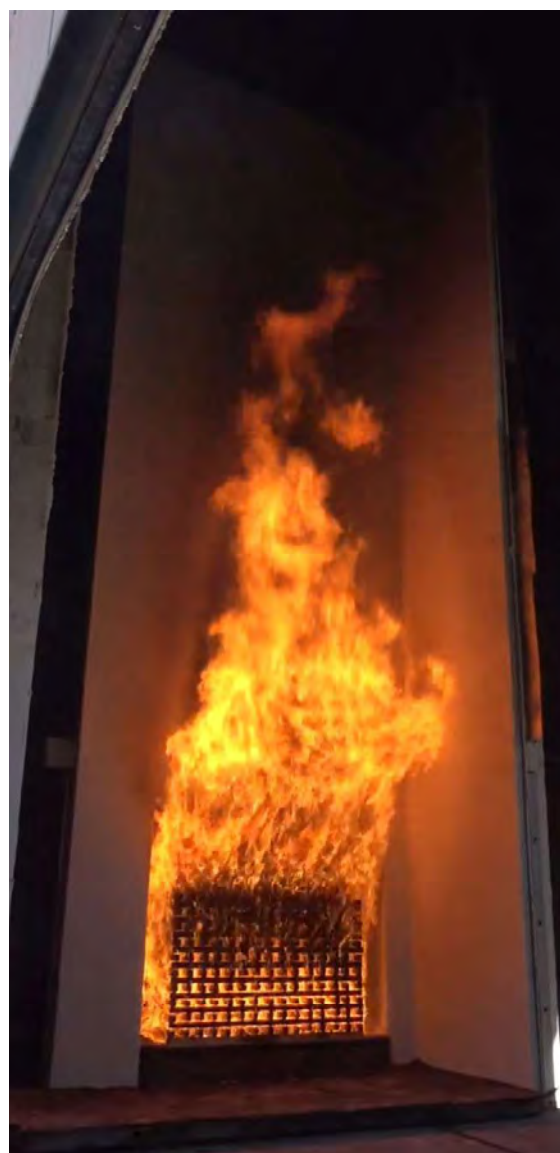
FIGURE 16:

START AND 10 MINUTES

08:40	Fire impacts on Level 2. Impact on render is observed
11:34	Horizontal cracks on centreline joint appear up to 3m
14:36	Centreline control joint increases its opening

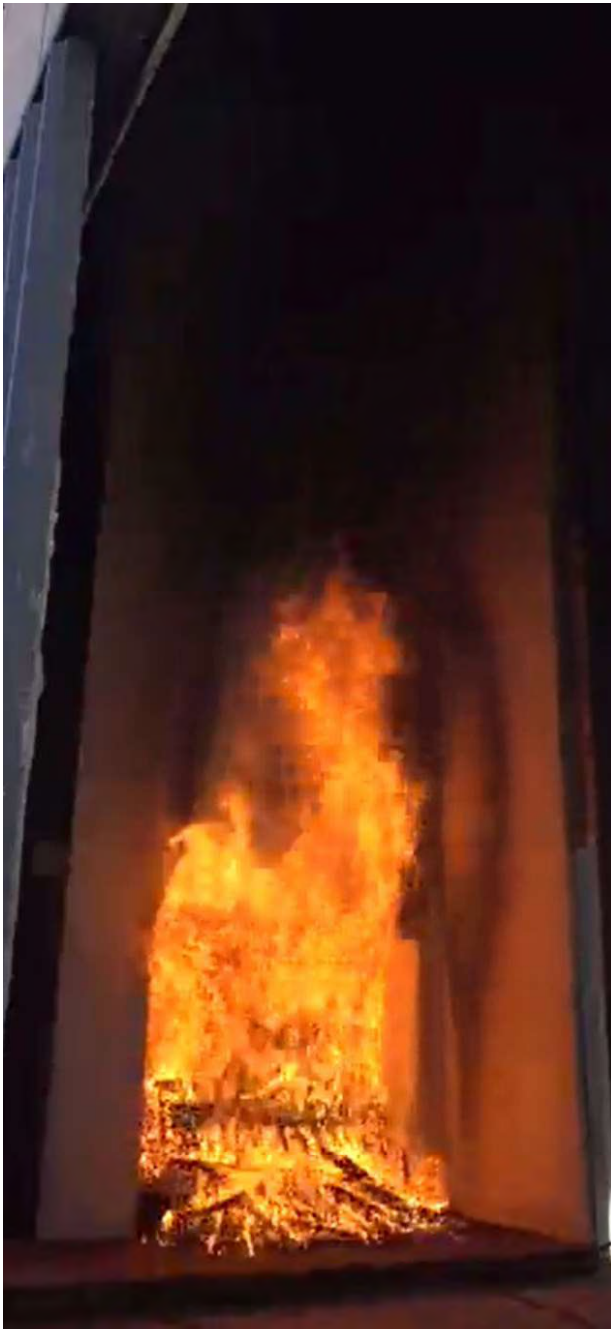
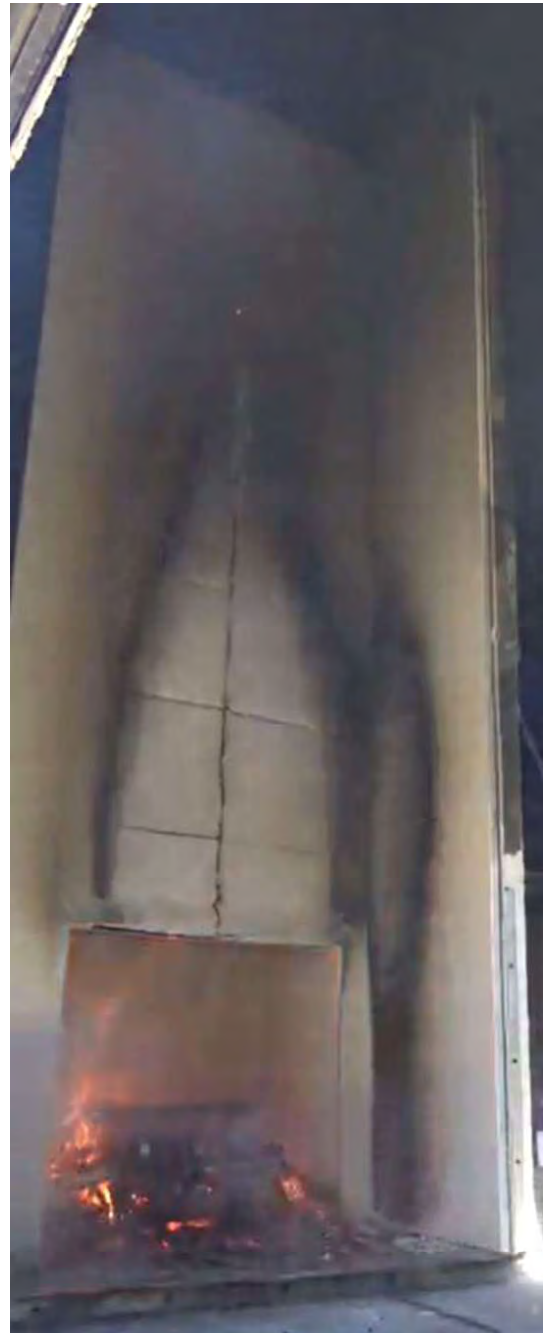
FIGURE 17:
CRIB COLLAPSE AND 30 MINUTES

15:00	Wing wall up to Level 1 has soot impact
16:00	Centreline control joint crack extends to Level 2
18:18	Timber crib collapses
20:10	Centreline control joint has flaming up to 4m above combustion chamber

25:10	Cracks through render associated with the location of each QT Conpolcrete panel occur over main wall.
25:52	Small flames observed within centreline joint

26:25	Small continuous flaming in centreline crack above combustion chamber
32:45	Timber crib extinguished
30:16 to 60:00	Wall is observed to smoke over centreline joint for remainder of observation time. No observation of flaming during this time occurred.

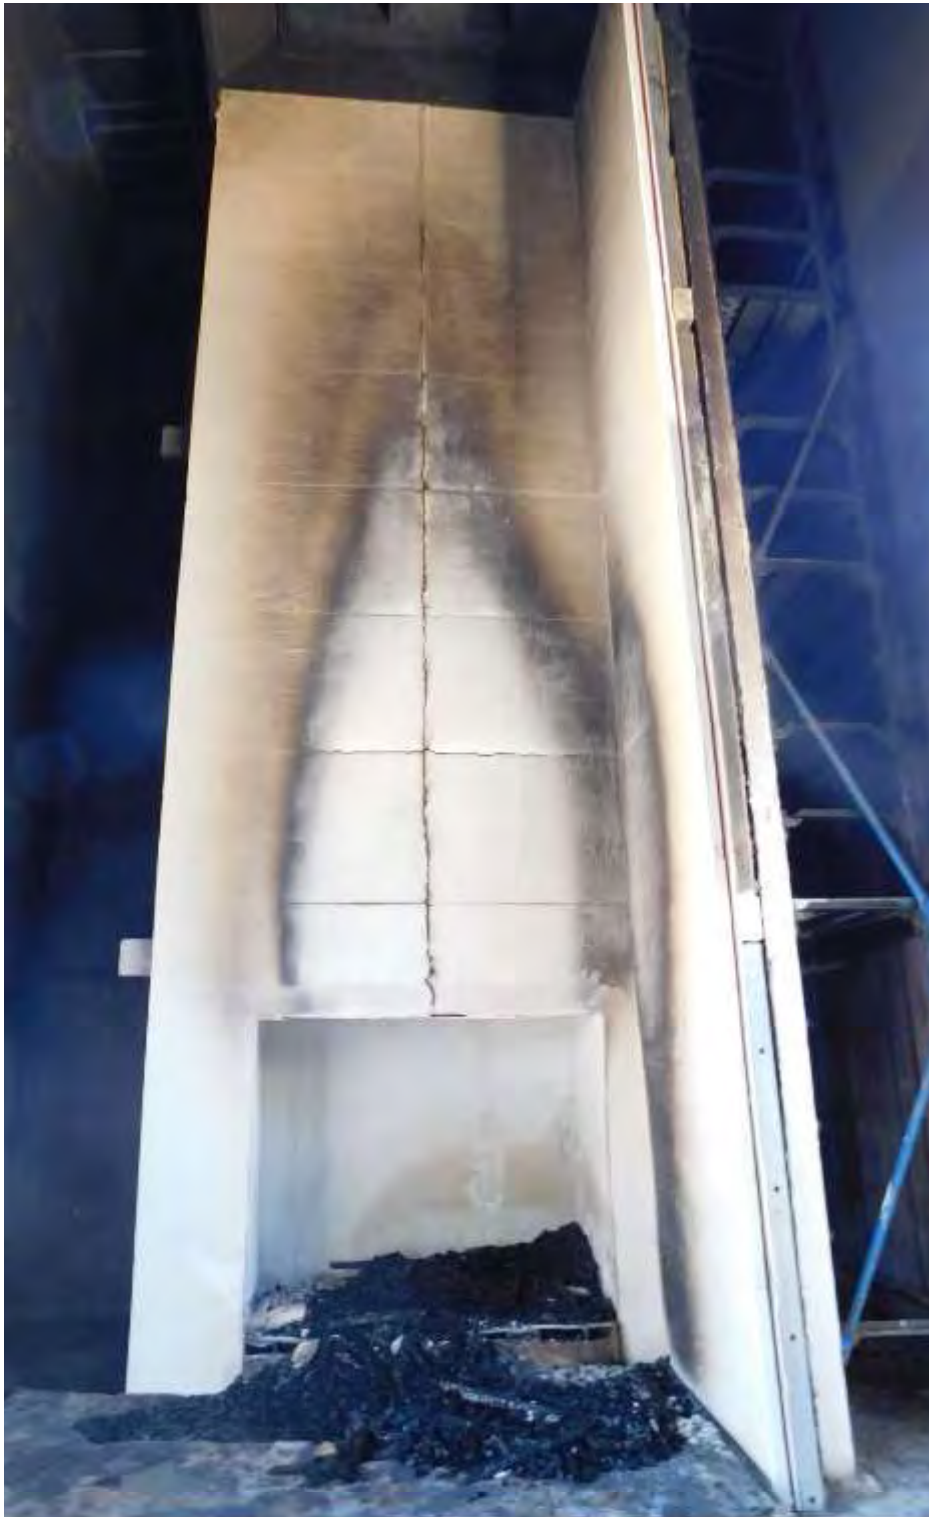
FIGURE 18:

EXTERNAL WALL

From the above image, the QT Conpolcrete panel detailed minor impact along the vertical centreline of the specimen. No observations of fire impact on the plasterboard wall occurred.

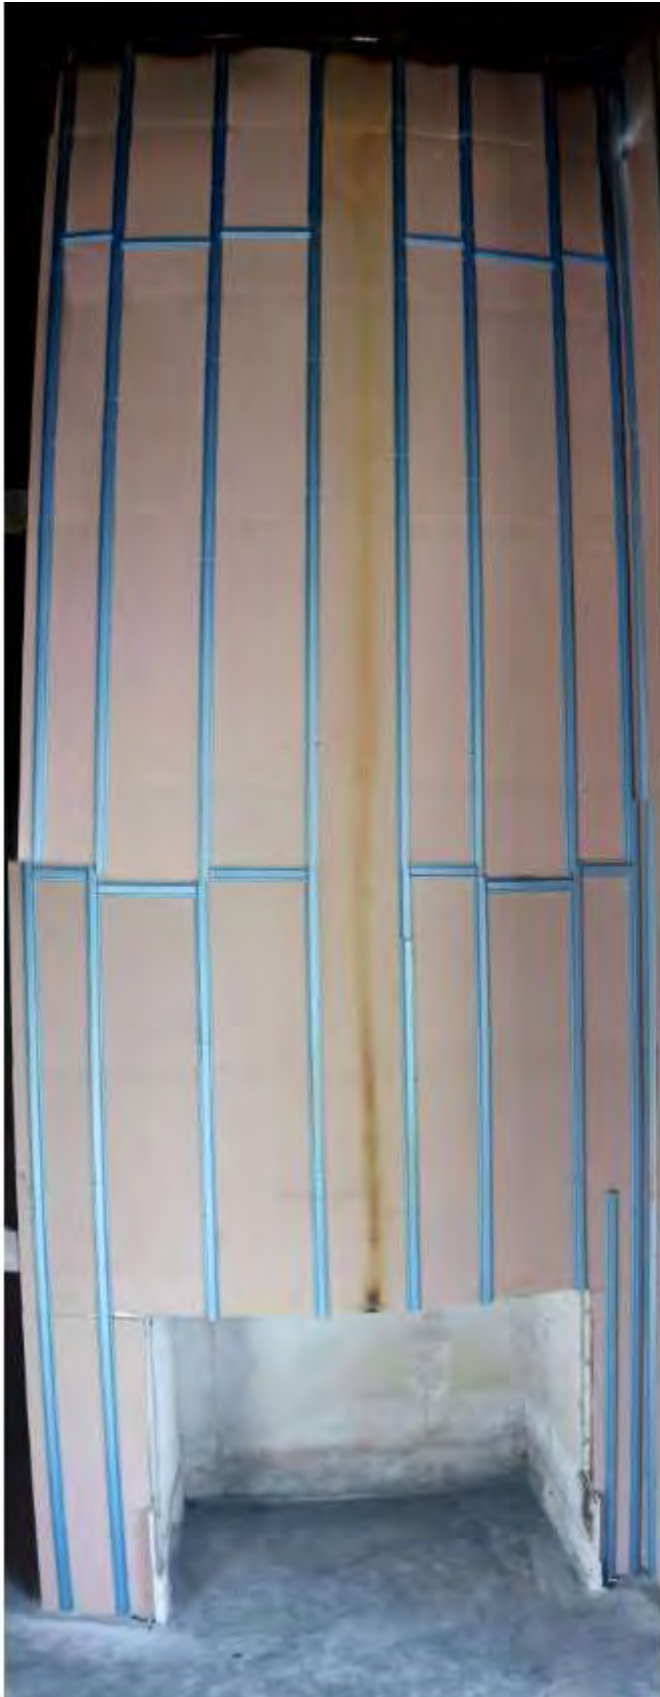
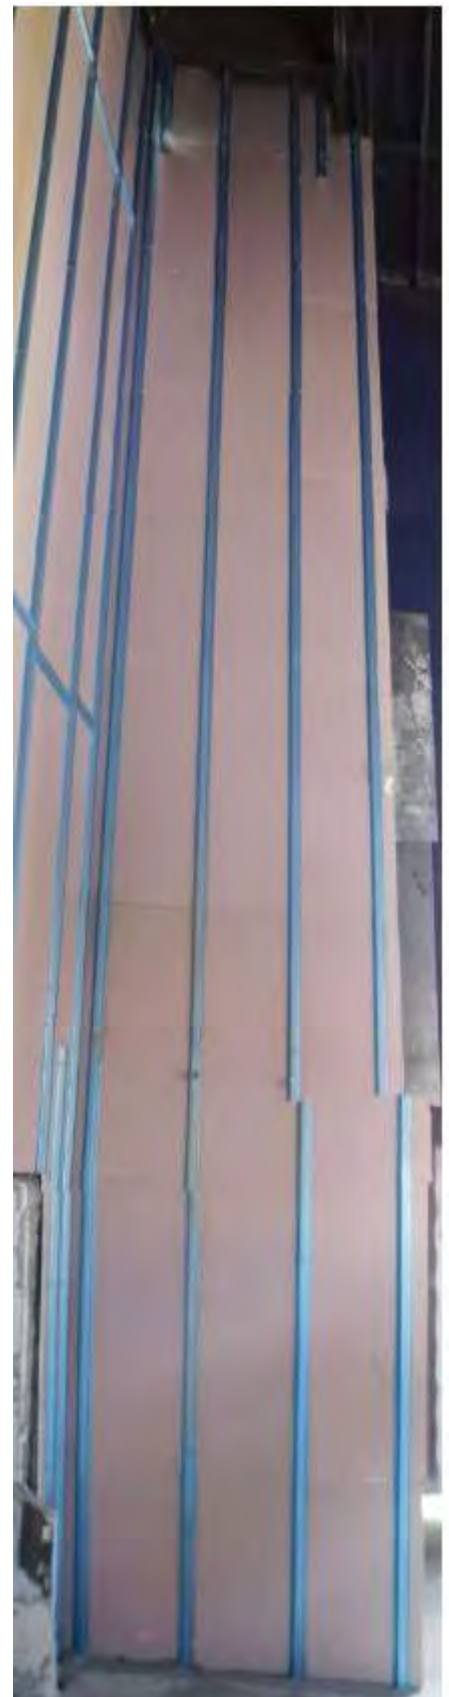
FIGURE 19:
PLASTERBOARD FIRE IMPACT
